Testing mechanical characteristics of chestnut stakes used in bed sills for stream restoration

Abstract

Journal of Agricultural Engineering 2017; XLVIII:655

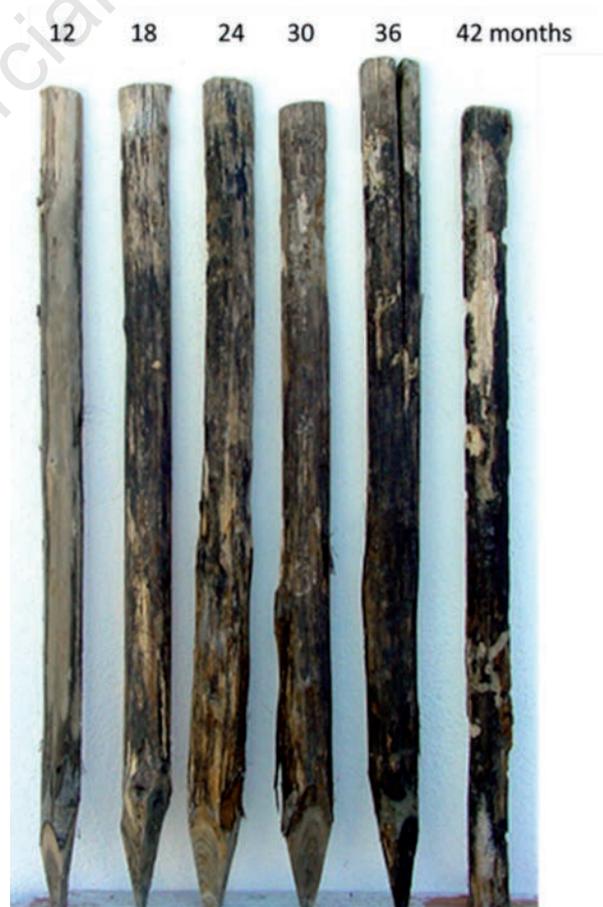
Figure 1. View of the chestnut stakes corresponding at different times from sill construction (Burruano *et al.*, 2008).

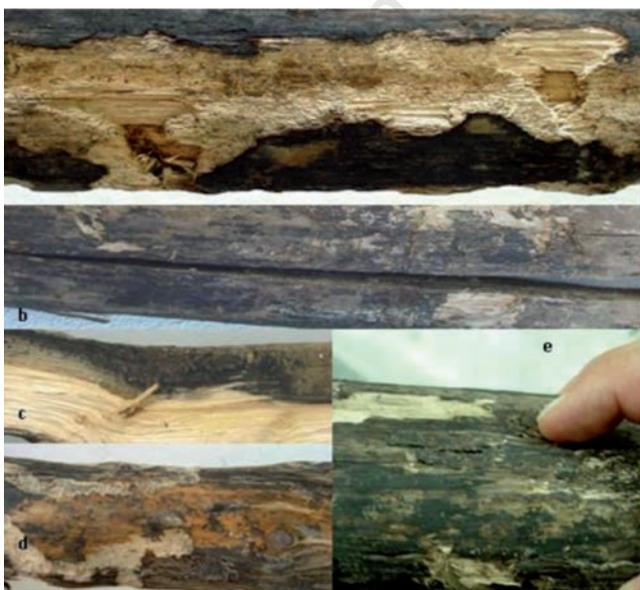
Figure 2. Types of alterations of the chestnut stakes.

of the stakes and xylem discolorations occur after 24 months (Figure 2) and that fungi belonging to the *wood-decay* group of Basidiomycetes were detected only on samples extracted after 30 months.

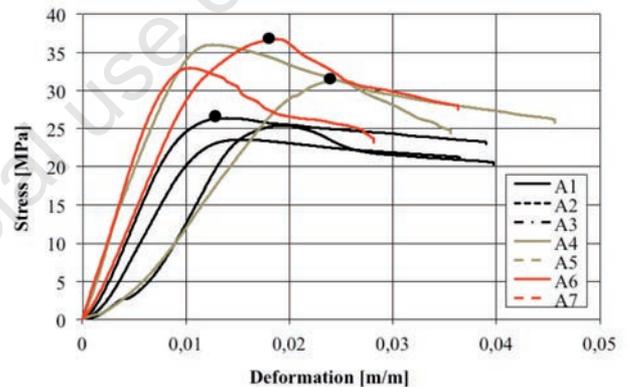
Figure 3. Determining the compressive strength in the stress-deformation experimental curve.

The compressive strength was identified as the maximum stress value in the stress-deformation experimental curve (Figure 3). The compressive stiffness was calculated as the slope of the straight line connecting the experimental points corresponding to 10 MPa and 20 MPa. In the experimental range 10-20 MPa tested wood samples generally showed a linear behaviour.

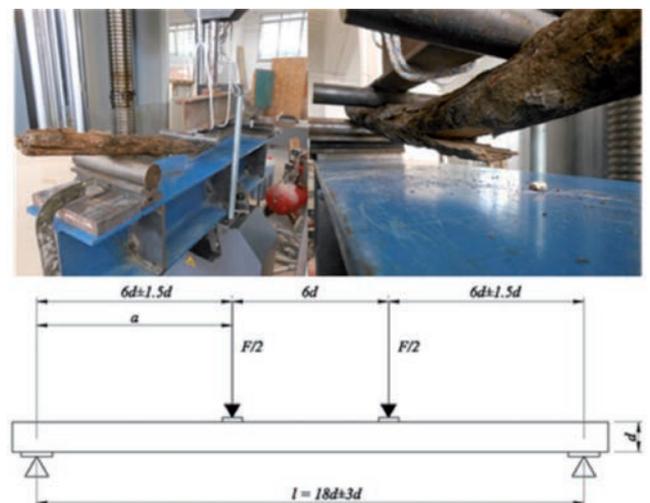
Figure 4. View of the bending test and scheme for calculating the flexural strength according to UNI EN 408-2012 standard.

The bending tests were carried out on both the stake C and another one (named D), collected after 120 months from the sill construction. This test was performed applying the UNI EN 408-2012 standard which requires a four-point bending test (Figure 4) with a sample length greater than $18d$, being d the mean sample diameter. The tolerance of the distance between the standing points is equal to $3d$ while the distance between the loading points is equal to $6d$. Stake D had a length equal to 108 cm and a diameter equal to 5 cm. As a consequence, the distance between the standing points was fixed to 88 cm while the distance between the loading points was equal to 30 cm.

According to UNI EN 408-2012 standard, the flexural strength was calculated by the following relationship (Figure 4):

The break did not involve all the stake cross-section (Figure 4) and, at the end of the unloading phase of the bending test, the sample get back almost all the deformation occurred during the test. In order to evaluate the wood-ageing effect on the bending behaviour, the same bending test was carried out on an undisturbed stakes (namely I1). The main characteristic of this stakes is length equal to 110 cm and mean diameter equal to 6.1 cm. A distance between the standing points equal to 92 cm was used and a distance between the loading points equal to 30 cm, as for the bending test of the stake D, was applied. The maximum applied load (13707 N) has been reached in 334 seconds and the corresponding bending strength is equal to 94.2 MPa, very close to the literature value. Figure 7B shows that the bending characteristics of stake D are worse than those of stake I1: the maximum load of stake D is 2953 N while for the stake I1 is equal to 13707 N (reduction of the maximum load equal to 78%); the bending strength of stake I1 is equal to 94.2 MPa while for the stake D is equal to 69.8 MPa, with a percentage reduction of 26%.

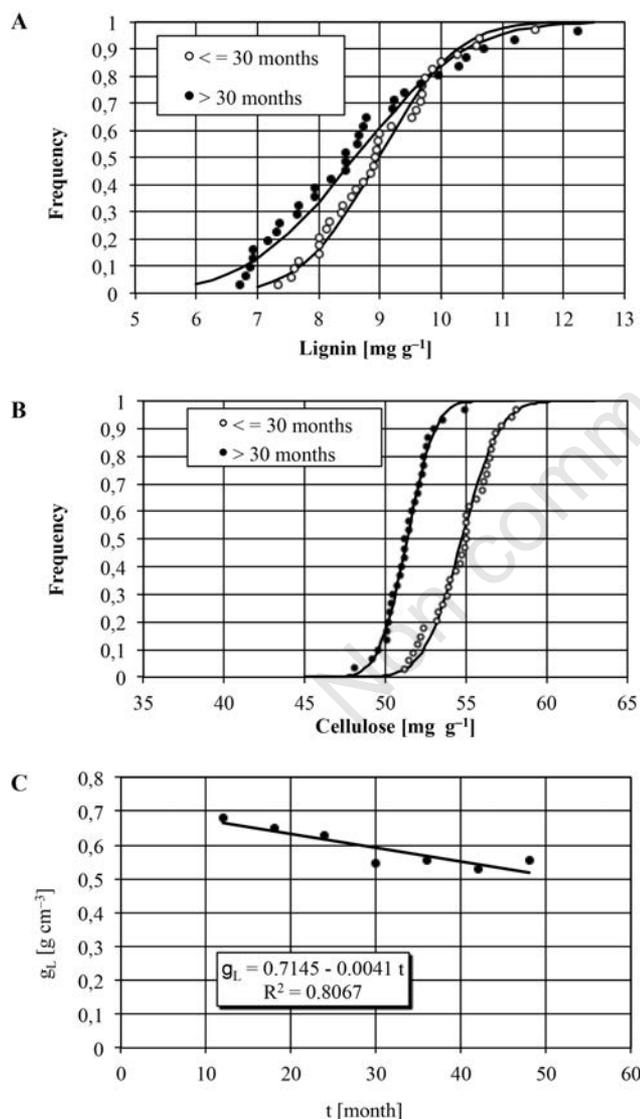
Figure 5. Empirical frequency distribution of the cellulose/lignin content (A, B) and wood specific weight (C) of the investigated chestnut stakes.

According to this hypothesis that the cellulose/lignin content measurements belong to two different statistical populations ($t \leq 30$ months and $t > 30$ months), Figure 5 shows the comparison between the empirical frequency distribution of the cellulose/lignin content and the normal distribution and demonstrates that their content decreases with time t .

The values of the wood specific weight decrease with time (Figure 5) and, in particular, in 48 months a percentage reduction equal to 18.4% occurred. The mean specific weight of the chestnut

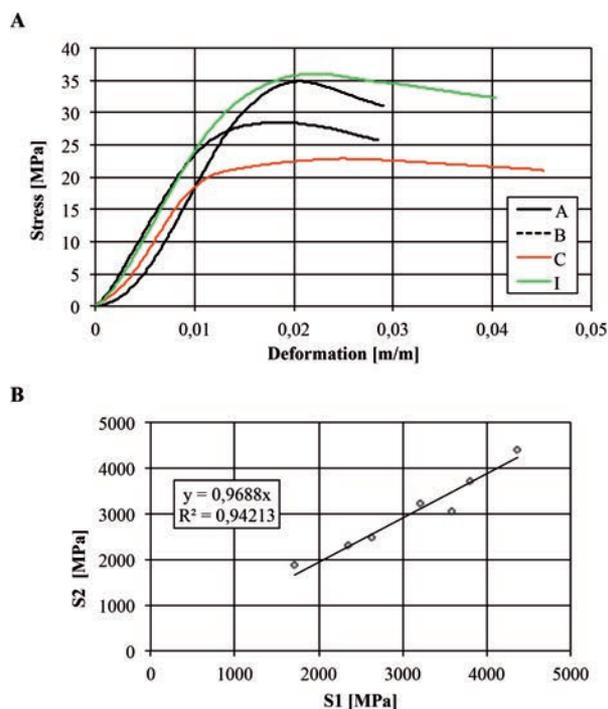
Figure 6. A) Mean stress-strain experimental curve for the investigated stakes; B) relationship between S1 and S2 estimates of the stiffness.

The results of the compressive tests, performed on the samples extracted from stakes A and B (96 months after the construction of the bed sill), C (after 102 months) and two undisturbed (I) stakes, are plotted in Figure 6A. In particular, for each stake (A, B, C, I), Figure 6A shows the *mean* stress-strain experimental curve obtained averaging the ones corresponding to all available samples.

The compressive strength values of the stake A (23-37 MPa) and B (25-42MPa) are close to the ones measured for the undisturbed stakes (32-40 MPa) showing that after 96 months this compression characteristic is close to the condition of the undisturbed stake. Conversely the strength values of the stake C (17-27 MPa) show that the effect of the wood ageing, due to physical and chemical alteration processes, is quite appreciable after 102 months.

In the diagram deformation-stress the range 10-20 MPa, which is represented by a straight line, corresponds to an elastic behaviour of the wood (Figure 6A). For verifying the hypothesis that the compressive stiffness can be calculated as the slope of the straight line connecting the two experimental points corresponding to 10 MPa and 20 MPa (namely S1), *i.e.* the relationship deformation-stress is linear in the range 10-20 MPa, the stiffness S2 corresponding to the slope of the linear relationship of all pairs deformation-stress (which vary from 60 to 120 for each test) in the range 10-20 MPa was also calculated. Figure 6B shows, as an example for the stake A, that the relationship between S1 and S2 is a straight line with a slope quasi equal to 1; in other words the two estimates of the stiffness are close and the relationship deformation-stress can be assumed linear in the range 10-20 MPa.

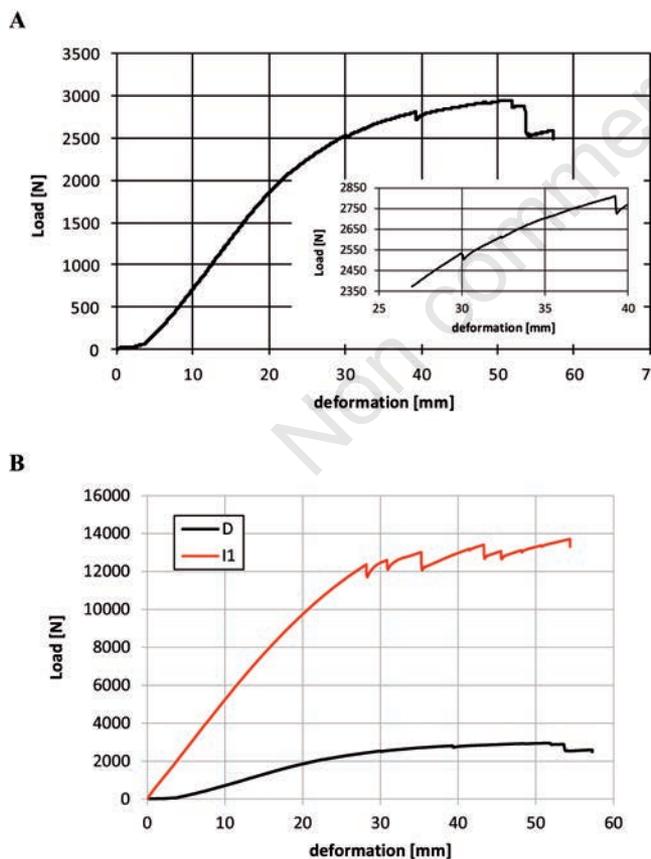
Figure 7. A) Results of the bending test for the chestnut stake D collected after 120 months; B) Comparison between the bending characteristics of stake D and the undisturbed stake I1.

The results of the bending test in the case of the chestnut stake D collected after 120 months from the sill construction are plotted in Figure 7A. This figure clearly shows that, after an initial phase of adaptation between the tested stake and the loading system, the load-displacement relationship is linear until a load equal to 1500 N. Applying equation (1) for a measured value of the breaking load equal to 2959 N (Figure 7A) a bending strength equal to 69.8 MPa is obtained, which is lesser than the reference strength for chestnut (about 100 MPa). Figure 7A shows that, after a linear phase, a non-linear one is present and two local failures, which are pointed out by a sudden load drop, are localized for a load equal to about 2500 and 2800 N. After the maximum load (2959 N) is reached two further local failures occur and the second one corresponds to the stake break.
