# A test for monitoring erosion on the Cape Fear experimental hillslope using a low-cost camera

Remote sensing and image analysis are gaining popularity as low-cost, continuous alternatives to traditional soil erosion measurement methods. This technical note presents a comparison between direct erosion measurements and image-based estimates on a semi-natural hillslope, taken before and after an artificial rainfall event. Although discrepancies between the two methods ranged from 18% to 27%, the image-based approach successfully detects rills as small as 5-7 cm, highlighting its potential for real-time, continuous monitoring in field applications.

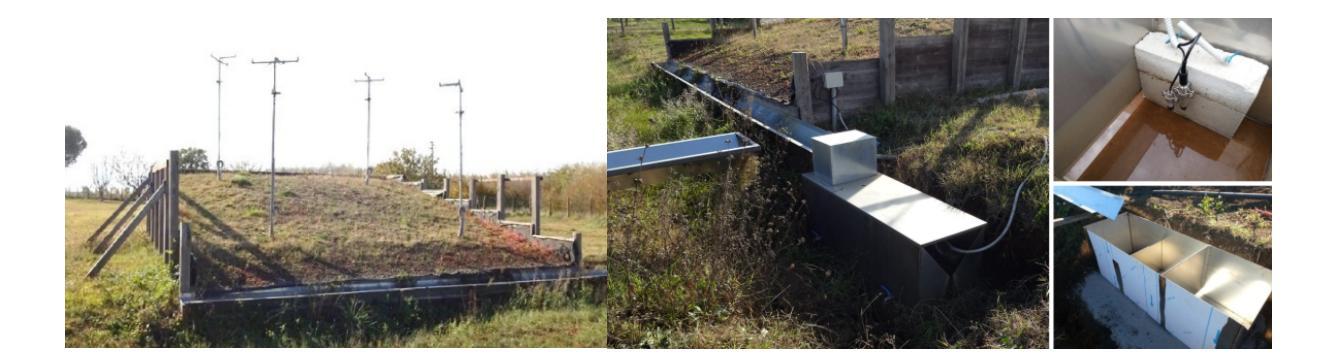
**Figure 1.** Cape Fear experimental plot. General view (left); detail of aluminum tank (center) with the interconnected compartments and the turbidity sensor (right, up and down).

Cape Fear experimental hillslope is a seminatural plot situated at the outdoor experimental farm of the University of Tuscia in Viterbo, Italy. The plot consists of 30 m<sup>3</sup> of natural wedge-shaped soil, as shown in Figure 1. The wedge covers a square area of  $7 \times 7$  m<sup>2</sup> and is supported by a containment structure

made of wooden boards and poles on three sides. It also has a foundation of an additional 10 m<sup>3</sup> of soil, which is isolated from the underlying ground by a waterproof plastic layer. To characterize the experimental hillslope soil, five undisturbed soil cores (0.07 m in length and 0.072 m in diameter) were collected from a depth of 0.05-0.12 m. On average, soil composition consists of 44% sand, 36% silt, and 20% clay. The saturated water content across the five samples ranged from 50% to 57%, with an average value of 54.4%.

Soil moisture, runoff, and turbidity are continuously monitored at a frequency of 1 Hz. Surface and subsurface runoff are collected in a V-shaped aluminum channel placed at the base of the plot. The runoff is directed into an aluminum tank, which consists of three interconnected compartments. This tank houses a stainless-steel OBS-3+ turbidity sensor and a structural testing system with a strain gauge. Finer solid materials and water levels are continuously measured by the sensors, while coarser solid materials are retained in the first compartment of the tank.

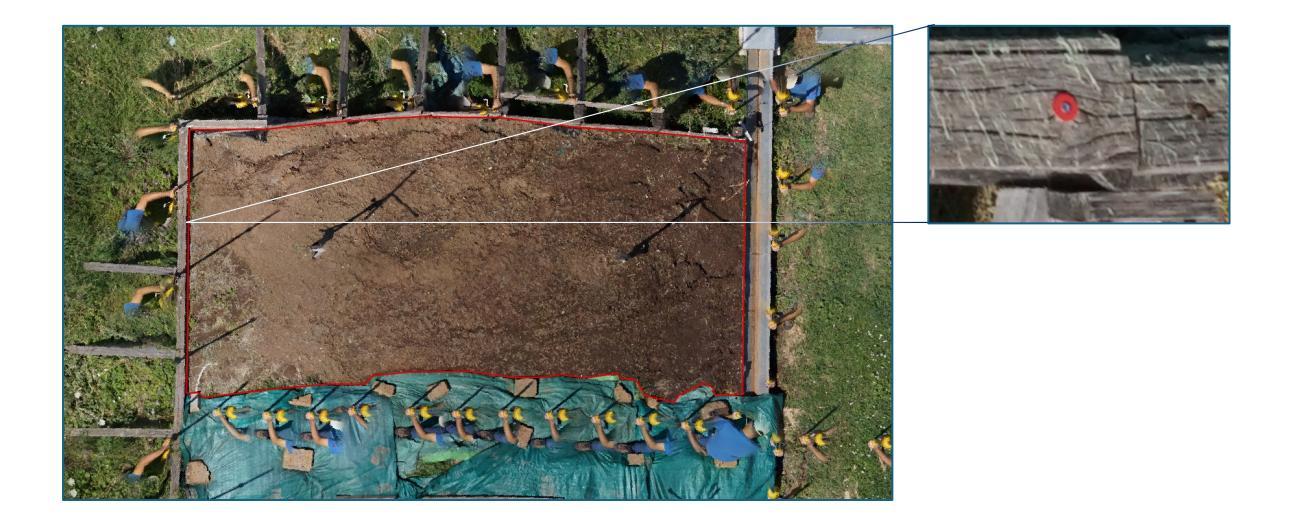
**Figure 2.** Photo captured at roughly one-meter intervals along the perimeter of Cape Fear's experimental area. In the detail, one of the 14 ground control points.

Before data processing, 14 Ground Control Points (GCPs) (Figure 2) were placed on the external surface of Cape Fear's containment structure, using threaded screws and washers that were pre-painted to enhance contrast. The topographic survey was conducted with a Topcon total station to accurately determine the coordinates.

The first photographic dataset was acquired on July 19, 2023, before the artificial rainfall event. Photos were taken approximately 1 meter apart, covering the perimeter of Cape Fear's experimental area while avoiding interference with the ground surface (Figure 2).

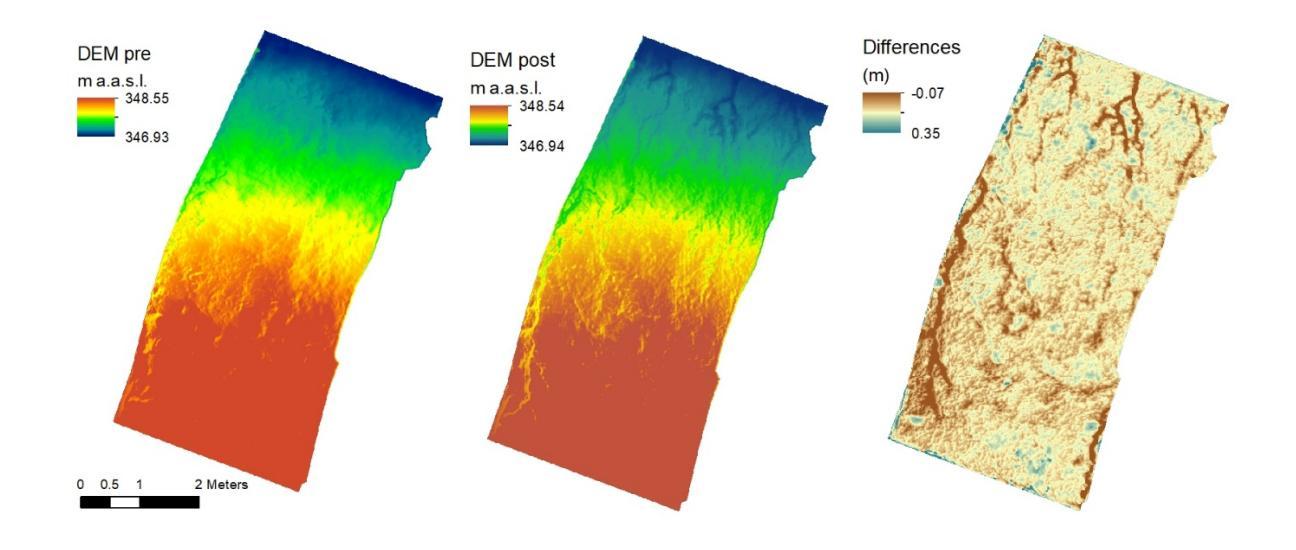
Figure 3. Pre-event DEM (left), post-event DEM (center), differences post-pre-event (right).

Regarding quantitative results, Figure 3a and 3b shows the DEMs generated before and after the artificial rainfall event, while Figure 3c presents the raster of elevation differences. As shown in Figure 3c, areas of deposition (in green, up to a maximum of 3.5 cm) and areas of erosion (in brown, up to a maximum of 7 cm) are observed within the study area.

From Figure 3c, by summing the differential values for each individual pixel of the raster and multiplying by the unit surface area of the pixel, it is possible to determine a total eroded volume equal to 221,593 cm<sup>3</sup>. This value represents the total volume of soil and pores containing both water and air. To obtain the volume of the soil alone, the volume of the soil pores must be excluded from the total volume. The volume of the soil pores can be estimated by assuming a porosity slightly greater than the saturation moisture content. In general, soil porosity sets an upper limit on the amount of water the soil can retain. However, the saturation moisture content may be lower than the porosity if some pores are too small to effectively hold water (as with microscopic pores) or too large to retain water due to drainage. Given Cape Fear average saturated water content of 54.4%, a soil porosity in the range of 50%-55% is here assumed.

Regarding the qualitative results, the formation of several micro-rills is clearly observable in the upper portion of Figure 3, where visible surface alterations indicate concentrated flow paths induced by the artificial rainfall event. A closer examination is provided in Figure 4: panel (a) illustrates the pre-event surface conditions, while panel (b) shows the same area after the rainfall simulation, highlighting the emergence and deepening of rill structures. Panel (c) presents a differential analysis between the preevent and post-event Digital Elevation Models (DEMs), effectively visualizing areas of sediment removal and deposition. In particular, Figure 4 reveals erosion features reaching depths of up to 7 cm, as well as deposition areas with accumulations up to 3.5 cm in height.

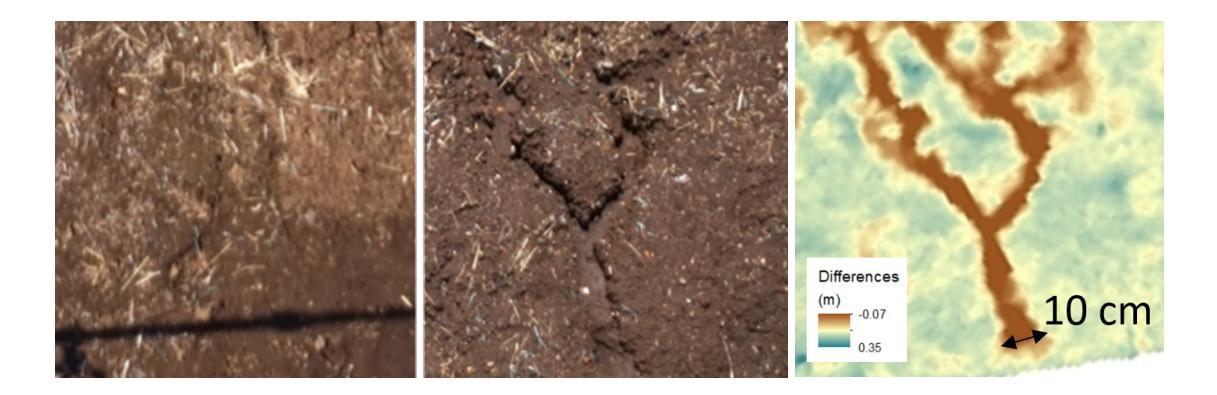
**Figure 4.** Particular of the lower section of the studied area: pre-event condition (left), post-event condition (center), micro-rills detected by image analysis (right).

Together, these images offer compelling visual evidence that the image-based analysis approach employed in this study is capable of detecting and monitoring micro-rill development with a high level of detail and spatial resolution.
